Flight Test – FINAL REPORT – Revision 2 - (7/10/14)

The EAGLE AOA display

Beechcraft King Air 90 Blackhawk

Alpha Systems Angle of Attack Stall Warning System

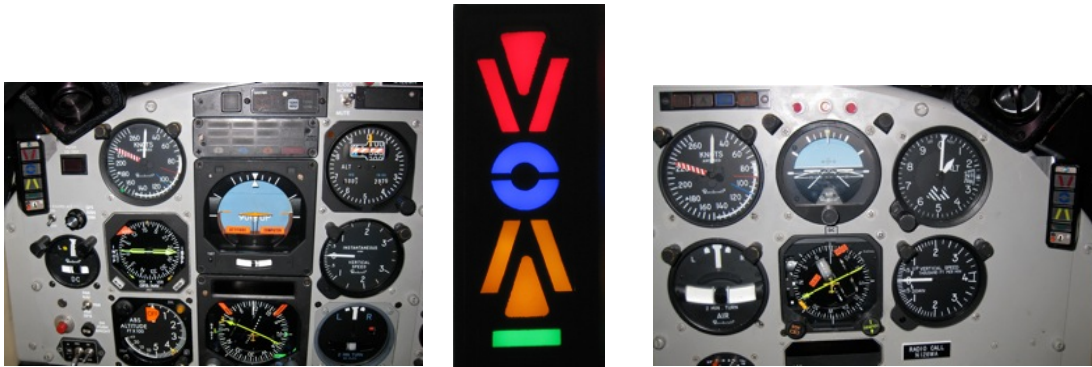
The Alpha Systems AOA Eagle Display provided visual and audible indications as shown in Figure 1 and Table II below. The two triangles are newly added:

**Alpha Systems AOA Stall Warning Eagle Electronic Display
Dual Eagle AOA Indicators in a King Air 90**

Condition	Display Indication
Cruise	Green Bar
Slowing From Cruise	Green Bar and Amber Triangle
Slowing Further From Cruise	Amber Triangle
Slow Flight	Amber Triangle and Amber Chevron
Very Fast (reference the donut)	Amber Chevron
Fast (reference the donut)	Amber Chevron and Lower Half of Blue Donut (Various callouts are available at this indication)
Slightly Fast (reference the donut)	Lower Half of Blue Donut
On Speed (OAA)	Full Round Blue Donut
Slightly Slow (reference the donut)	Upper Half of Blue Donut
Slow (reference the donut)	Upper Half of Blue Donut and Red Chevron
Very Slow (reference the donut)	Red Chevron
Ultra Slow (reference the donut)	Red Triangle

The Eagle Display proved easy to learn and intuitive. It was clear in its information, unambiguous and easy to comprehend. The arrangement of the donut, the new triangles, and chevrons in the display provided distinct information on proximity to stall and directive information that proved helpful at avoiding a near-stall condition, considerably before the aircraft's OEM audible stall warning system became effective. The newly-added Amber Triangle is a relatively large segment and when it comes alive, it draws a pilot's attention to the AoA instrument. That is very nice.

The two additional solid triangles are interesting. At first, I didn't see the purpose in having so many segments. Because I'm a "Keep It Simple" aviator, in some ways I still don't. But the Amber Triangle is a relatively large segment and is useful in drawing a pilot's initial attention to the previously-dark AOA display as it comes alive when slowing from Cruise, and then doubling in size as the adjacent Amber Chevron comes alive, too. That's nice. However I see no real purpose for the Red Triangle.
